TAMU Project

**Energy Consumption Data Quality Assurance/Quality
Control Assessment Report for the
Month of October 2016**

**Utility & Energy Services
Division of Administration
Texas A&M University**

November 2016

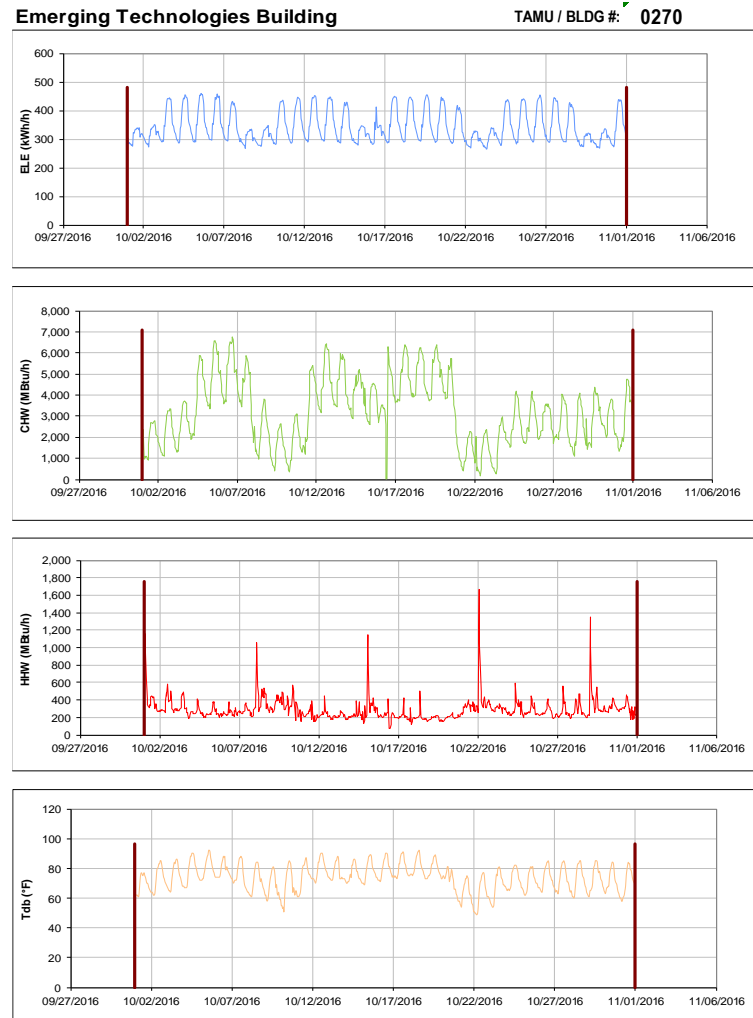
Figure III-1 Hourly Whole Building Electricity, Chilled Water, and Hot Water Consumption for Emerging Technologies Building during the Month of October 2016 and the Corresponding Hourly Outdoor Dry Bulb Temperature for College Station, TX

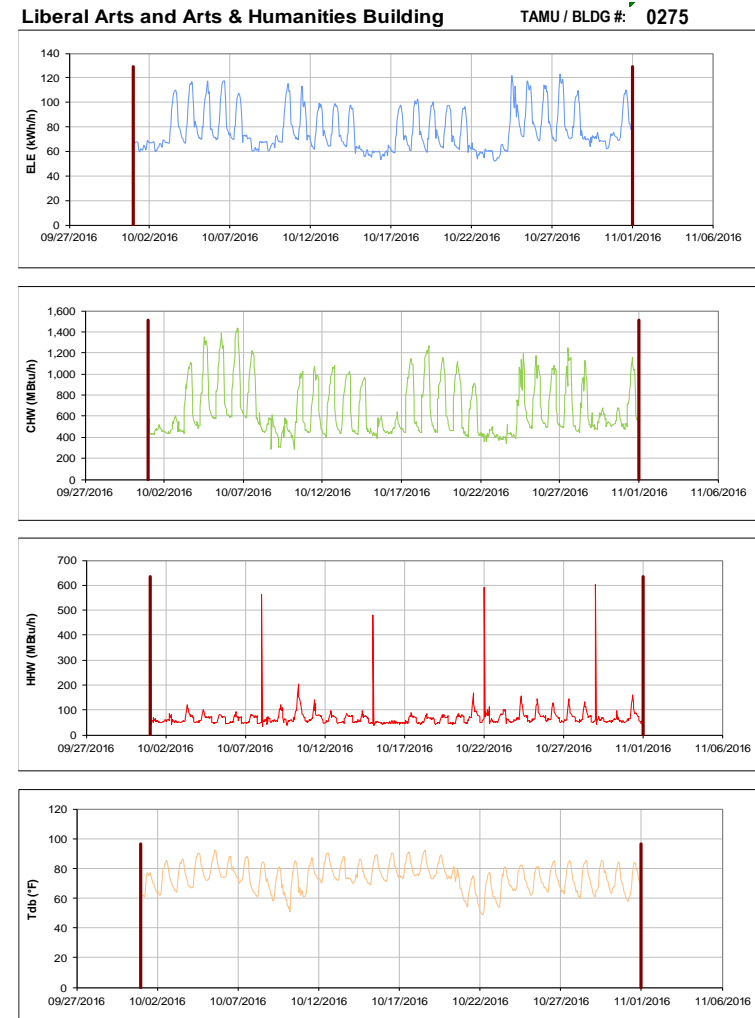
Figure III-2 Hourly Whole Building Electricity, Chilled Water, and Hot Water Consumption for Liberal Arts and Arts & Humanities Building during the Month of October 2016 and the Corresponding Hourly Outdoor Dry Bulb Temperature for College Station, TX

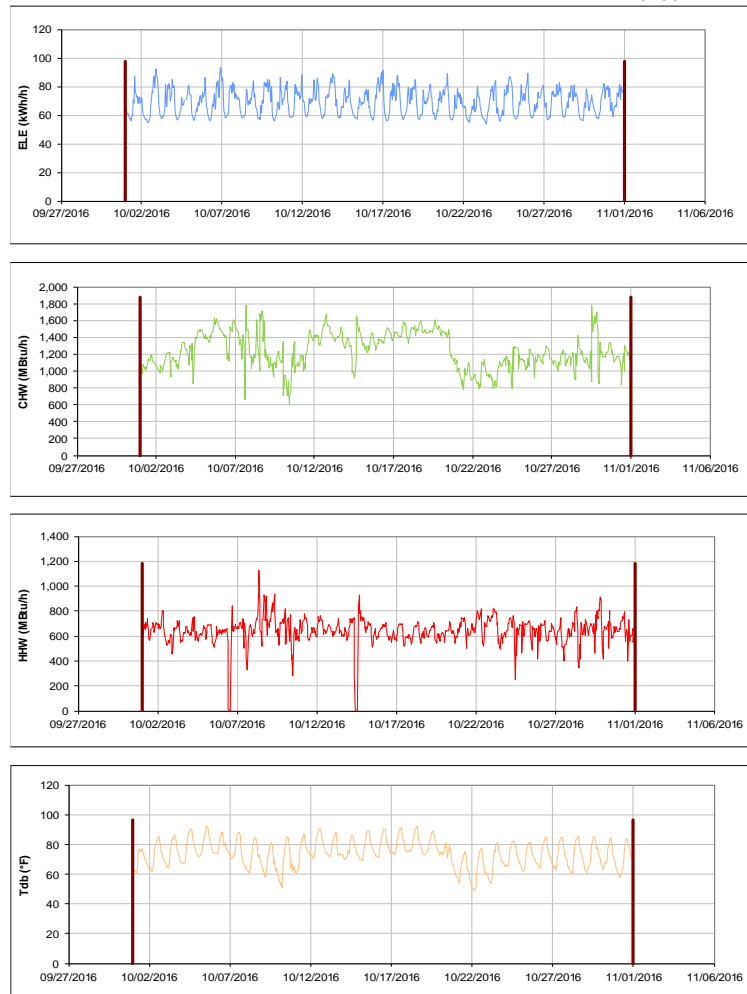
TAMU / BLDG #: 0290

Figure III-3 Hourly Whole Building Electricity, Chilled Water, and Hot Water Consumption for Wells Residence Hall during the Month of October 2016 and the Corresponding Hourly Outdoor Dry Bulb Temperature for College Station, TX

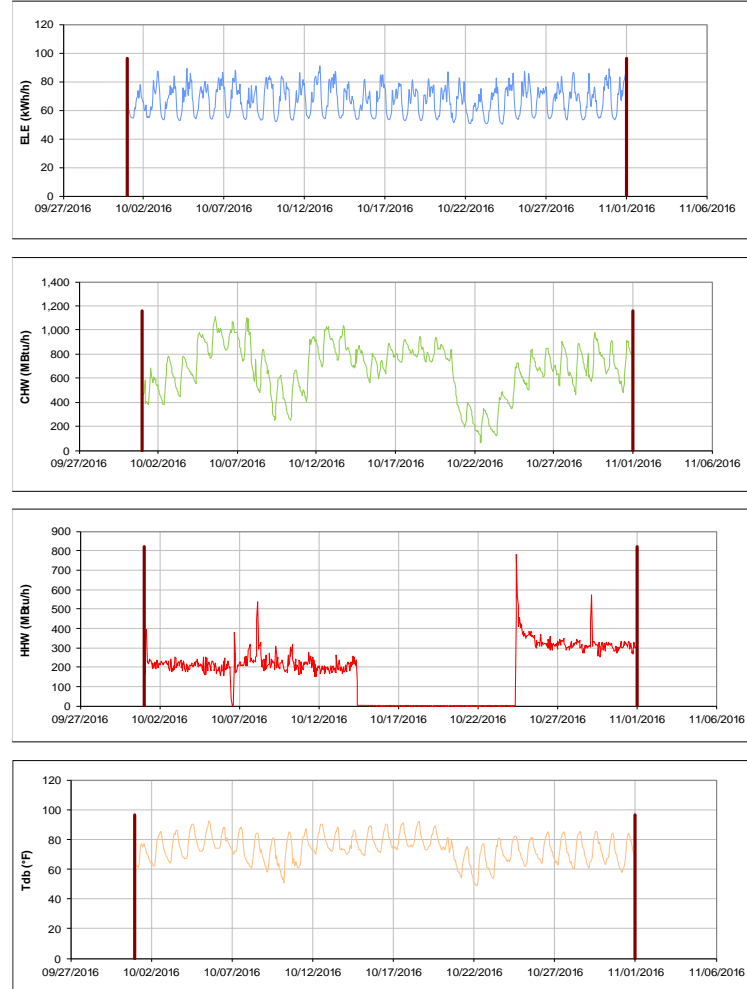
TAMU / BLDG #: 0292

Figure III-5 Hourly Whole Building Electricity, Chilled Water, and Hot Water Consumption for Eppright Residence Hall during the Month of October 2016 and the Corresponding Hourly Outdoor Dry Bulb Temperature for College Station, TX

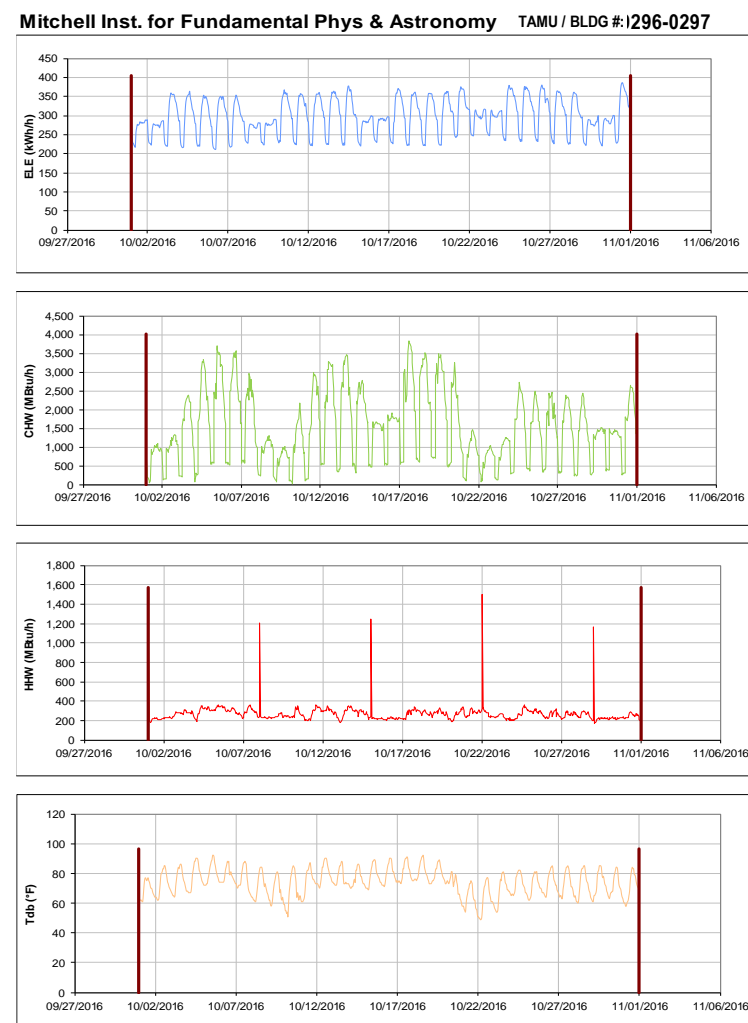
Figure III-8 Hourly Whole Building Electricity, Chilled Water, and Hot Water Consumption for Mitchell Inst. for Fundamental Phys & Astronomy during the Month of October 2016 and the Corresponding Hourly Outdoor Dry Bulb Temperature for College Station, TX

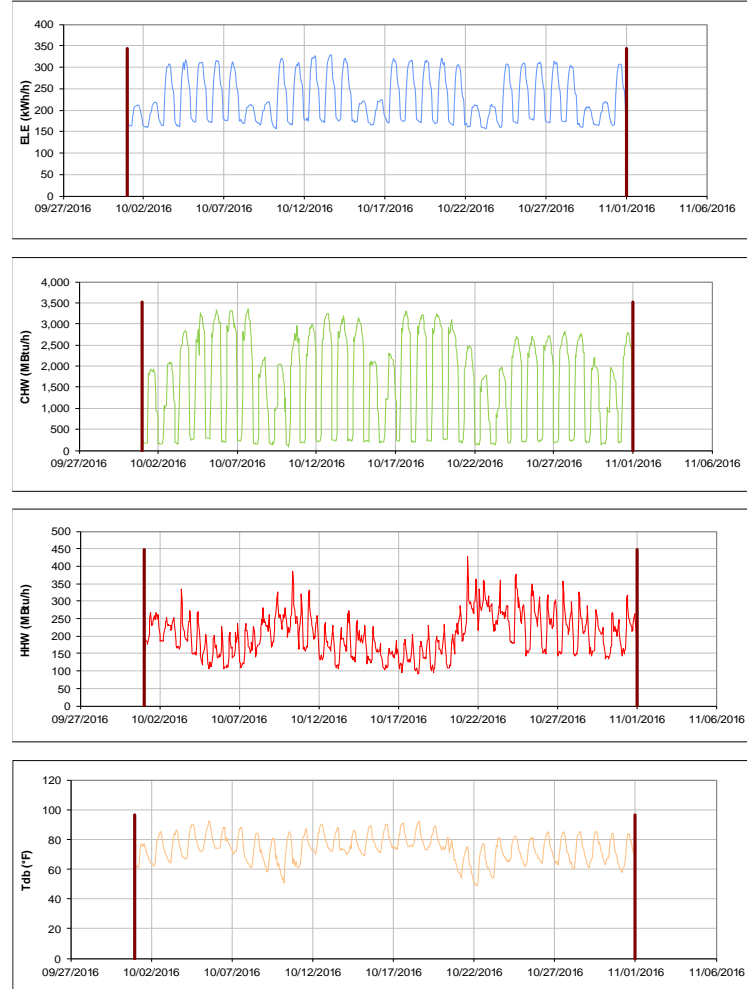
TAMU / BLDG #: 1325-0385

Figure III-9 Hourly Whole Building Electricity, Chilled Water, and Hot Water Consumption for CE TTI Office & Lab Building during the Month of October 2016 and the Corresponding Hourly Outdoor Dry Bulb Temperature for College Station, TX

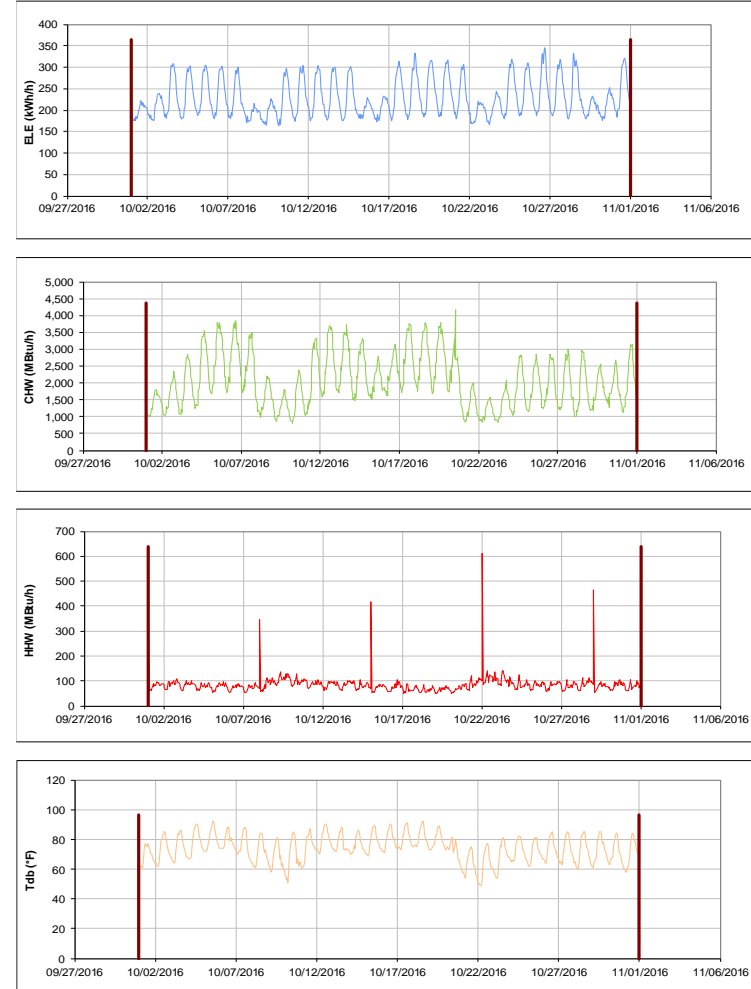
TAMU / BLDG #: 0353

Figure III-10 Hourly Whole Building Electricity, Chilled Water, and Hot Water Consumption for Bright Aerospace Building during the Month of October 2016 and the Corresponding Hourly Outdoor Dry Bulb Temperature for College Station, TX

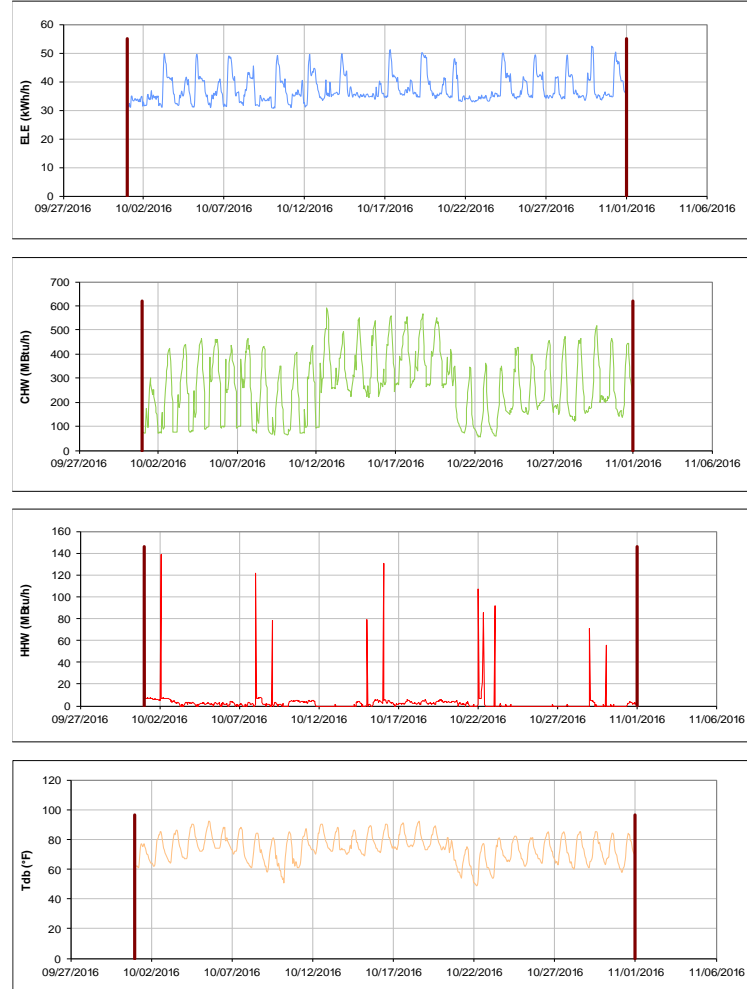
Davis Football Player Development Center TAMU / BLDG #: 0358

Figure III-11 Hourly Whole Building Electricity, Chilled Water, and Hot Water Consumption for Davis Football Player Development Center during the Month of October 2016 and the Corresponding Hourly Outdoor Dry Bulb Temperature for College Station, TX

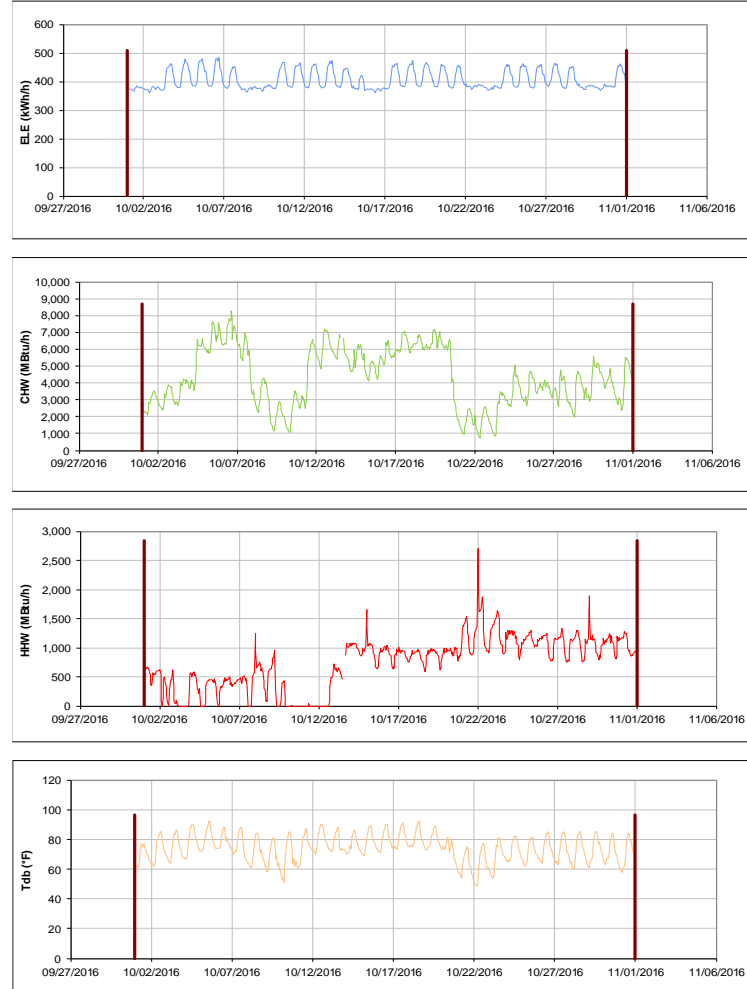
TAMU / BLDG #: 0376

Figure III-17 Hourly Whole Building Electricity, Chilled Water, and Hot Water Consumption for Chemistry Building Addition during the Month of October 2016 and the Corresponding Hourly Outdoor Dry Bulb Temperature for College Station, TX

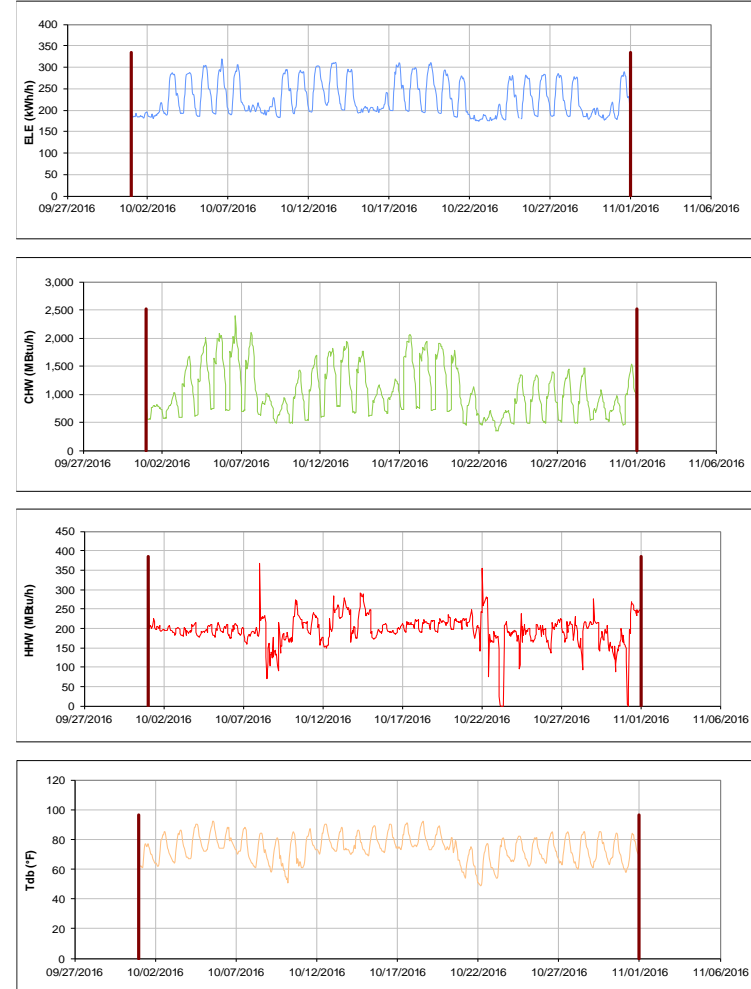
TAMU / BLDG #: 0383

Figure III-18 Hourly Whole Building Electricity, Chilled Water, and Hot Water Consumption for Koldus Building during the Month of October 2016 and the Corresponding Hourly Outdoor Dry Bulb Temperature for College Station, TX

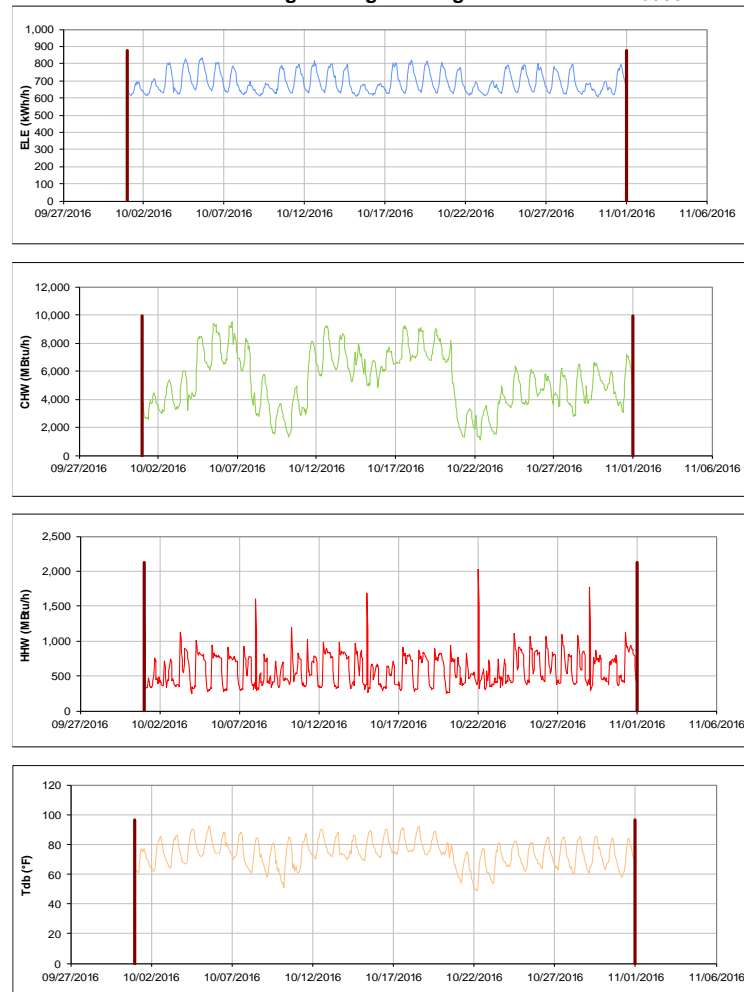
TAMU / BLDG #: 0386

Figure III-20 Hourly Whole Building Electricity, Chilled Water, and Hot Water Consumption for Jack E. Brown Chemical Engineering Building during the Month of October 2016 and the Corresponding Hourly Outdoor Dry Bulb Temperature for College Station, TX

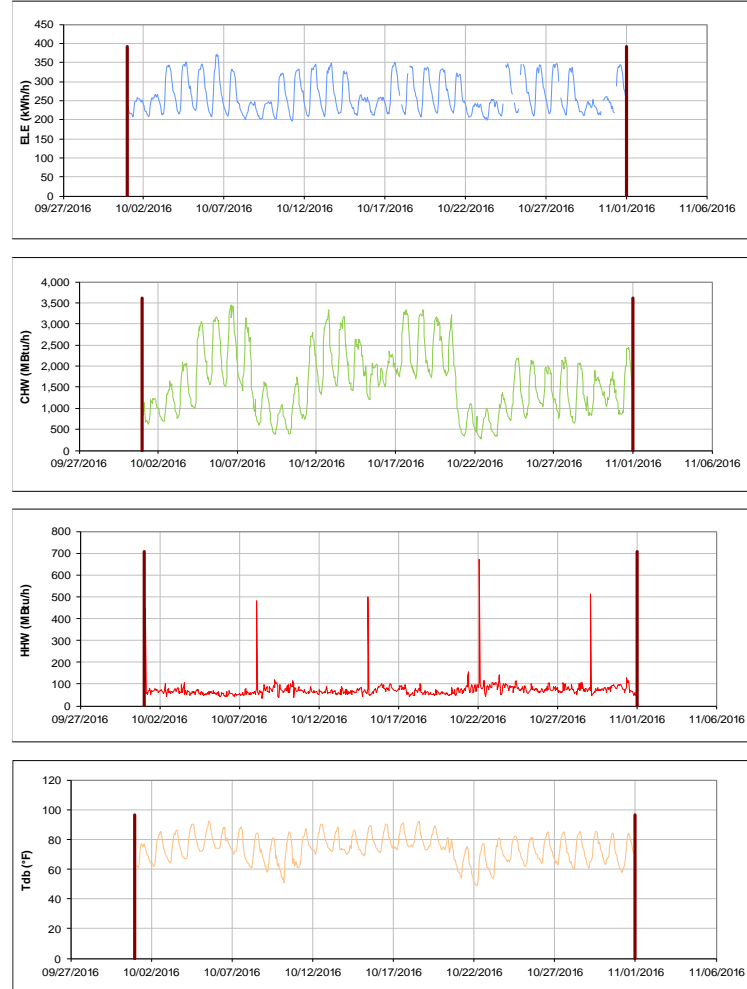
Richardson Petroleum Engineering Building TAMU / BLDG #: 0387

Figure III-21 Hourly Whole Building Electricity, Chilled Water, and Hot Water Consumption for Richardson Petroleum Engineering Building during the Month of October 2016 and the Corresponding Hourly Outdoor Dry Bulb Temperature for College Station, TX

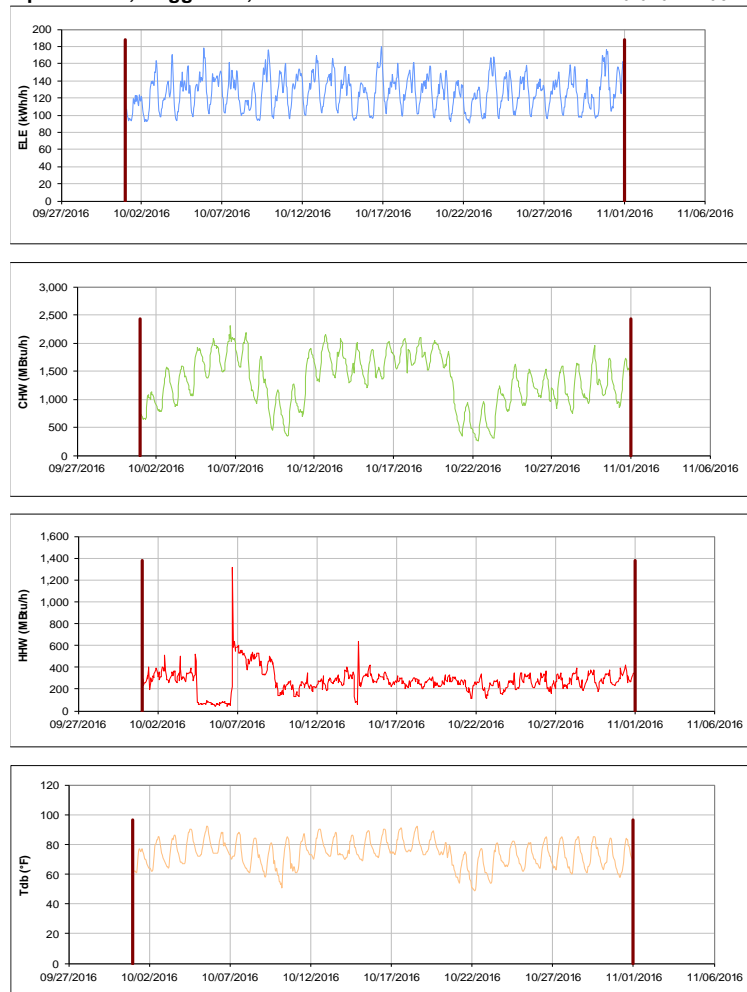
TAMU / BLDG #: 0-0402-1405

Figure III-25 Hourly Whole Building Electricity, Chilled Water, and Hot Water Consumption for Spence Hall, Briggs Hall, and Ash II LLC during the Month of October 2016 and the Corresponding Hourly Outdoor Dry Bulb Temperature for College Station, TX

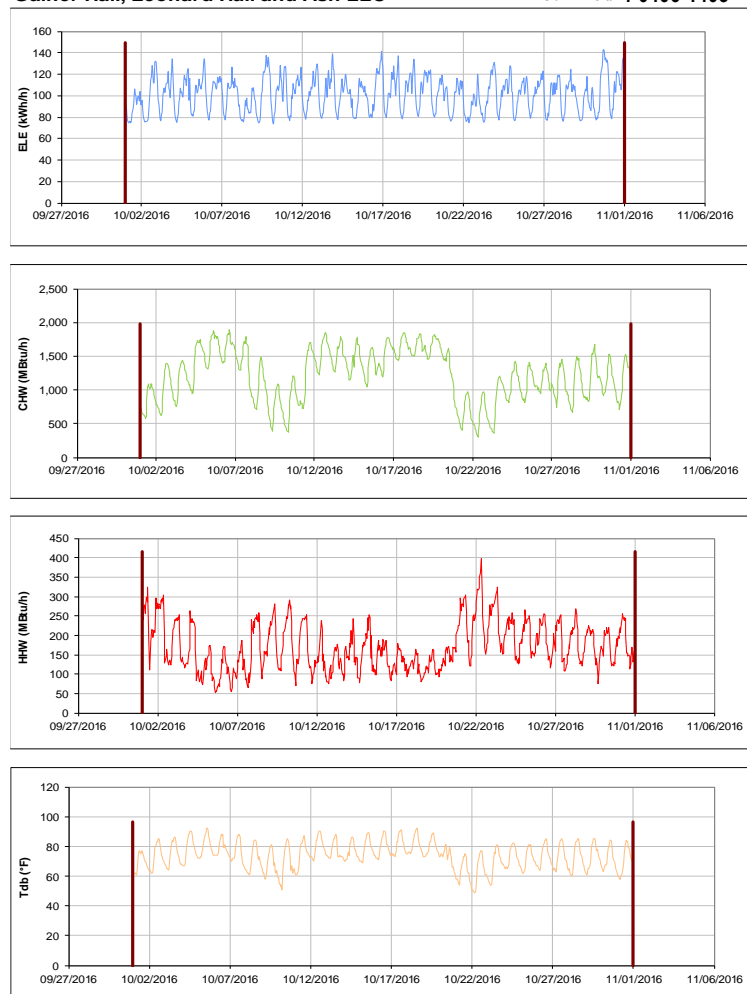
TAMU / BLDG #: 4-0406-1403

Figure III-33 Hourly Whole Building Electricity, Chilled Water, and Hot Water Consumption for Gainer Hall, Leonard Hall and Ash LLC during the Month of October 2016 and the Corresponding Hourly Outdoor Dry Bulb Temperature for College Station, TX

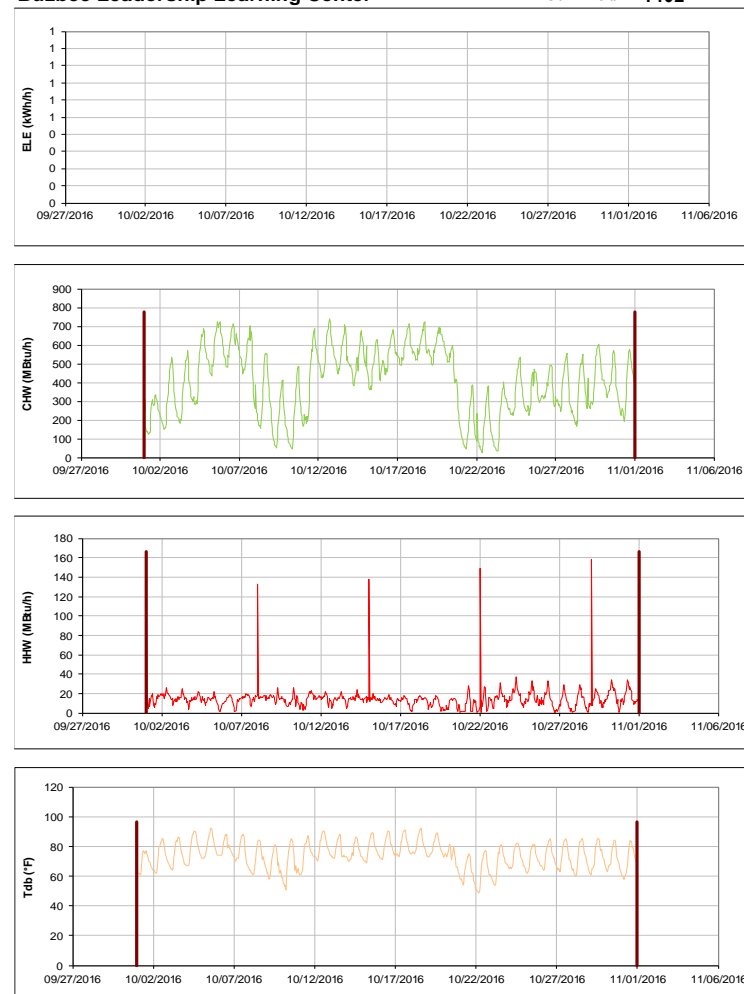
TAMU / BLDG #: 1402

Figure III-40 Hourly Whole Building Electricity, Chilled Water, and Hot Water Consumption for Buzbee Leadership Learning Center during the Month of October 2016 and the Corresponding Hourly Outdoor Dry Bulb Temperature for College Station, TX

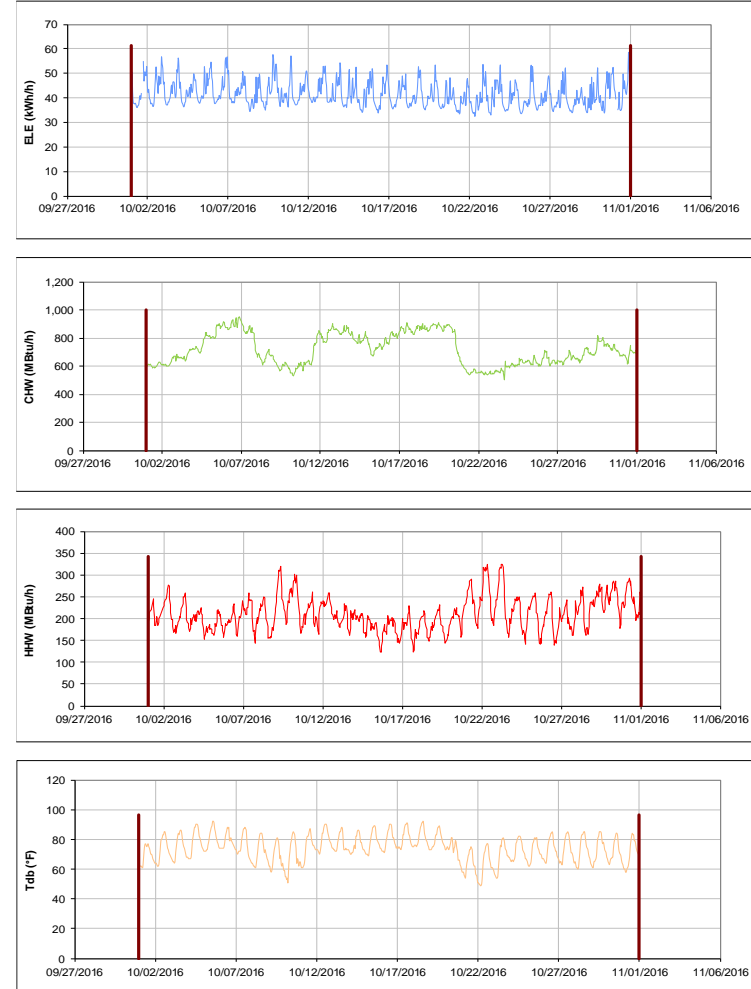
TAMU / BLDG #: 0415

Figure III-42 Hourly Whole Building Electricity, Chilled Water, and Hot Water Consumption for Davis-Gary Residence Hall during the Month of October 2016 and the Corresponding Hourly Outdoor Dry Bulb Temperature for College Station, TX

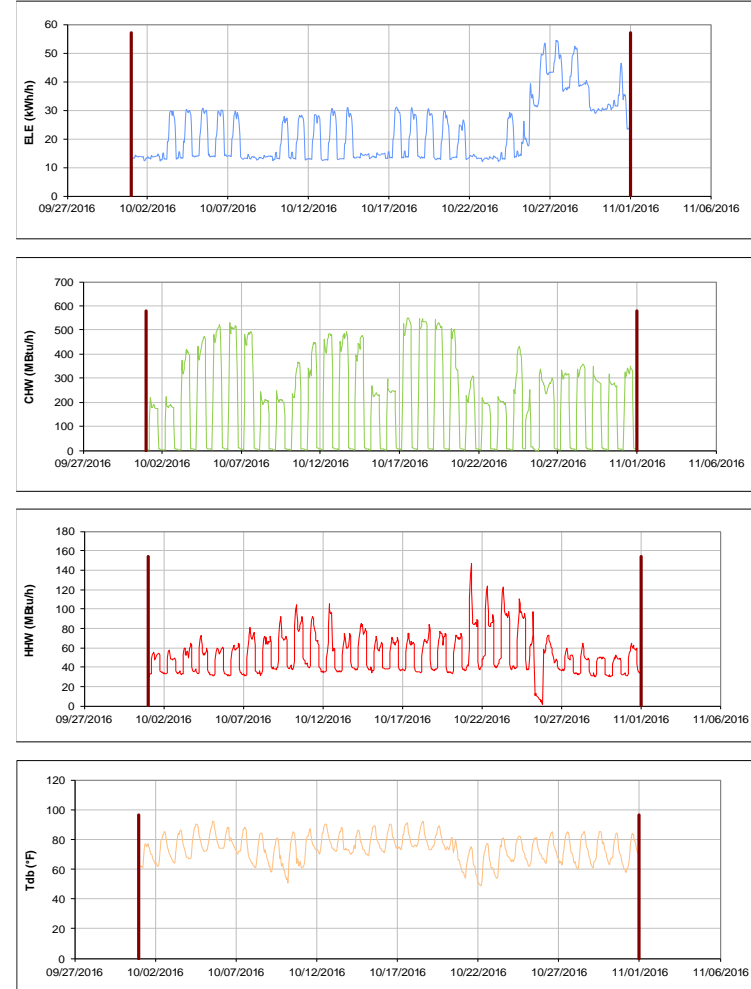
TAMU / BLDG #: 0424

Figure III-46 Hourly Whole Building Electricity, Chilled Water, and Hot Water Consumption for Hotard Hall during the Month of October 2016 and the Corresponding Hourly Outdoor Dry Bulb Temperature for College Station, TX

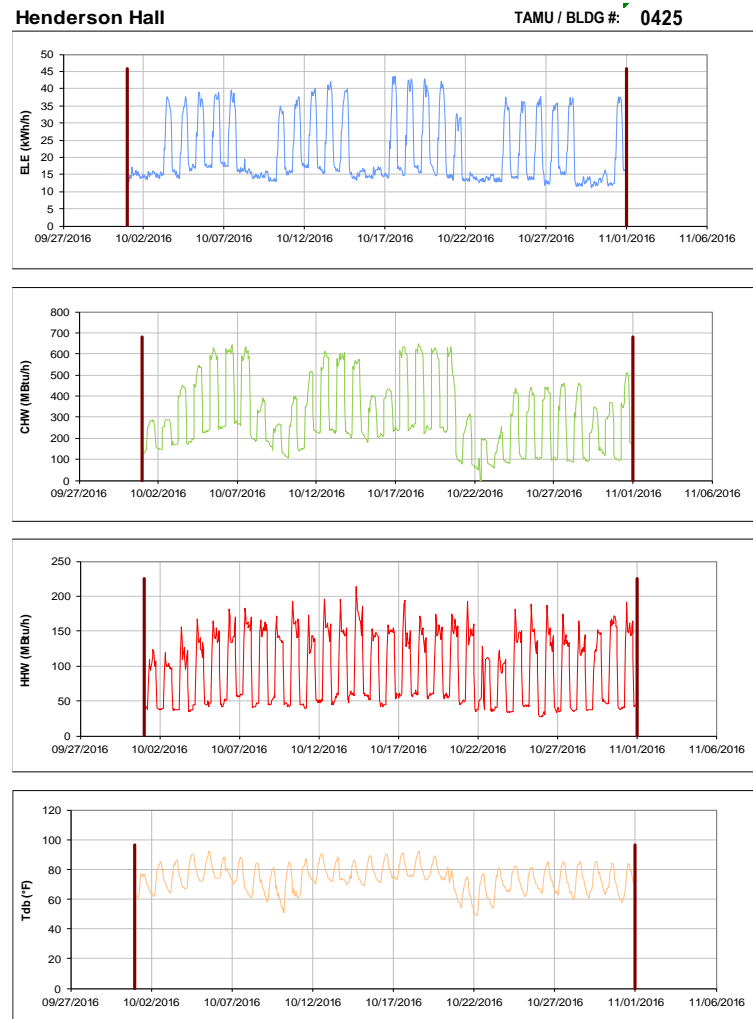
Figure III-47 Hourly Whole Building Electricity, Chilled Water, and Hot Water Consumption for Henderson Hall during the Month of October 2016 and the Corresponding Hourly Outdoor Dry Bulb Temperature for College Station, TX

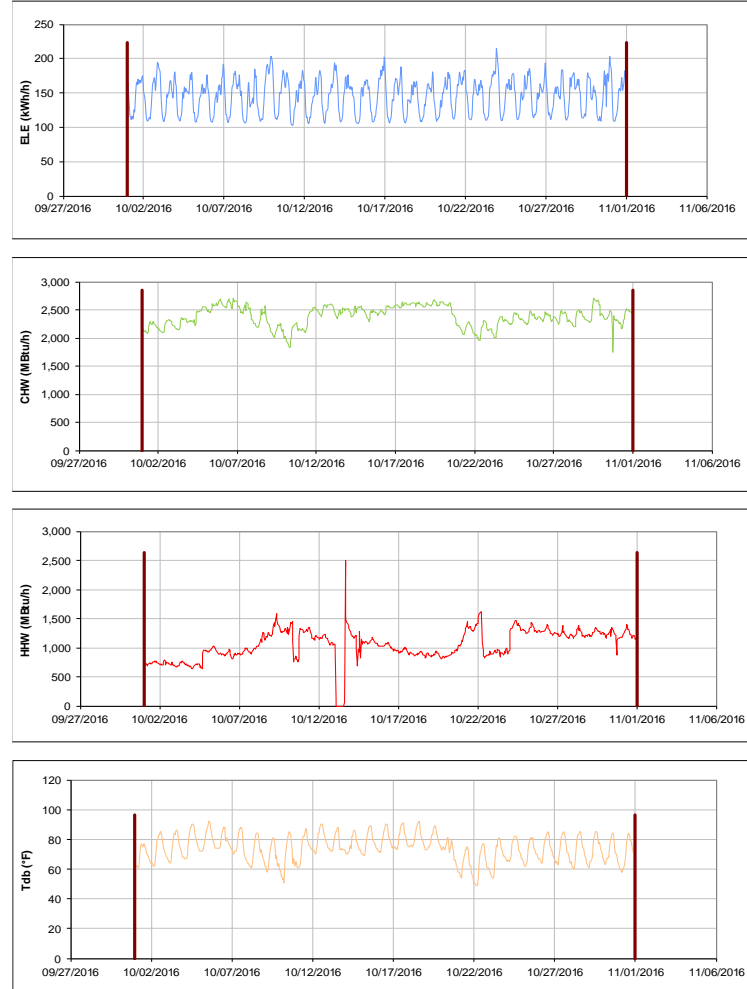
TAMU / BLDG #: 0433

Figure III-51 Hourly Whole Building Electricity, Chilled Water, and Hot Water Consumption for Mosher Residence Hall during the Month of October 2016 and the Corresponding Hourly Outdoor Dry Bulb Temperature for College Station, TX

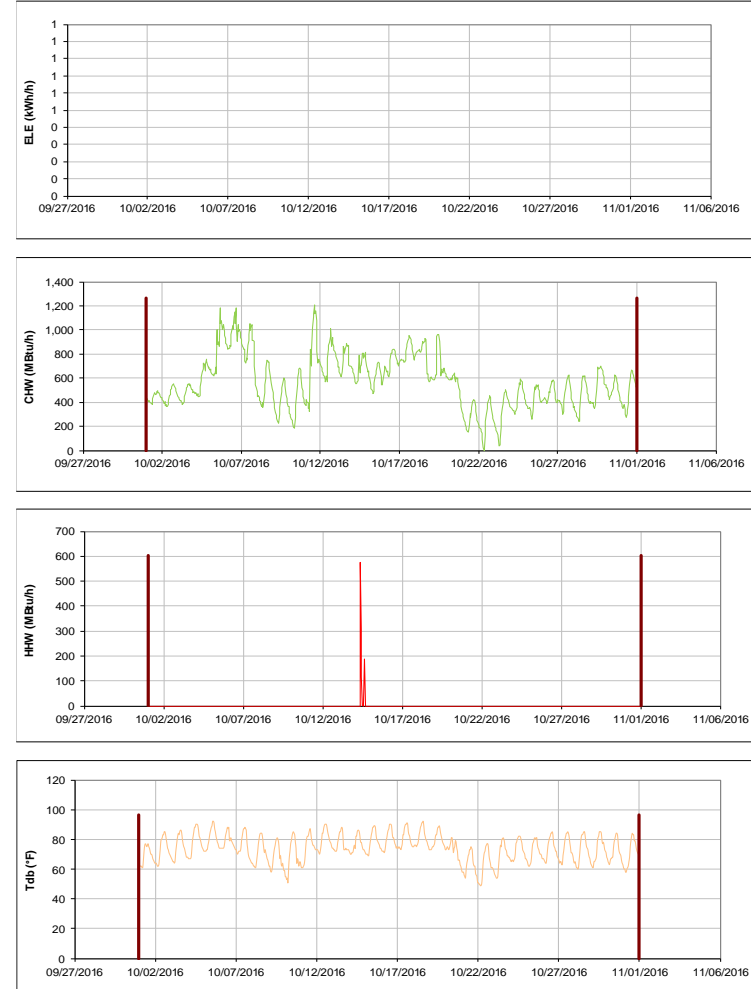
TAMU / BLDG #: 0440

Figure III-52 Hourly Whole Building Electricity, Chilled Water, and Hot Water Consumption for Commons Hall during the Month of October 2016 and the Corresponding Hourly Outdoor Dry Bulb Temperature for College Station, TX

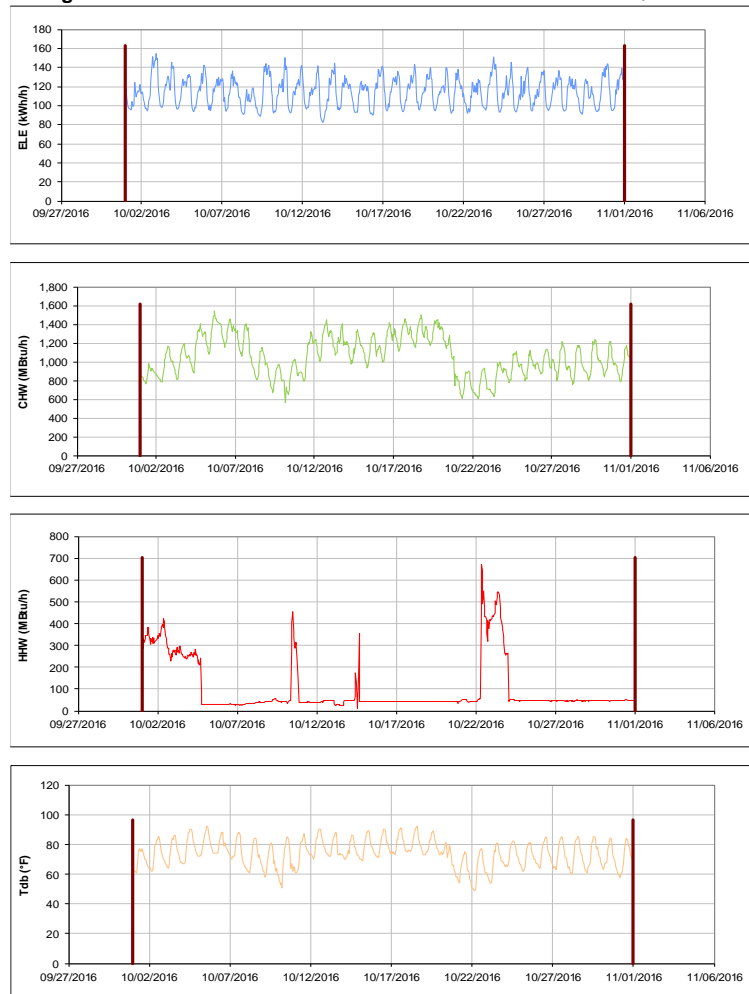
TAMU / BLDG #: 0441

Figure III-53 Hourly Whole Building Electricity, Chilled Water, and Hot Water Consumption for Krueger Residence Hall during the Month of October 2016 and the Corresponding Hourly Outdoor Dry Bulb Temperature for College Station, TX

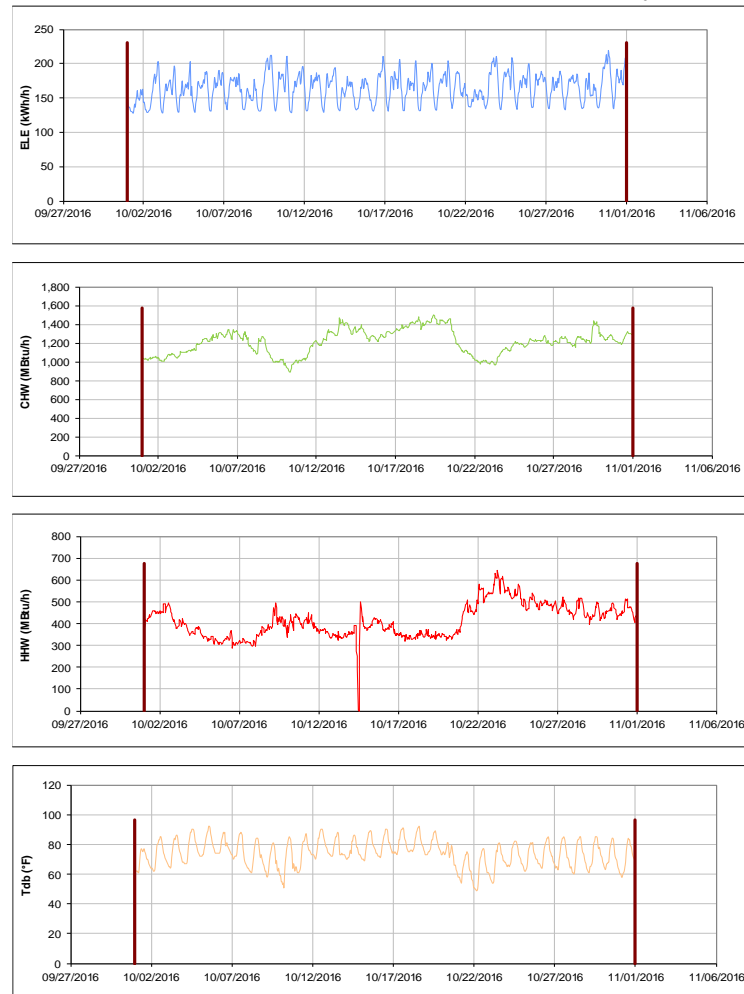
TAMU / BLDG #: 0442

Figure III-54 Hourly Whole Building Electricity, Chilled Water, and Hot Water Consumption for Dunn Residence Hall during the Month of October 2016 and the Corresponding Hourly Outdoor Dry Bulb Temperature for College Station, TX

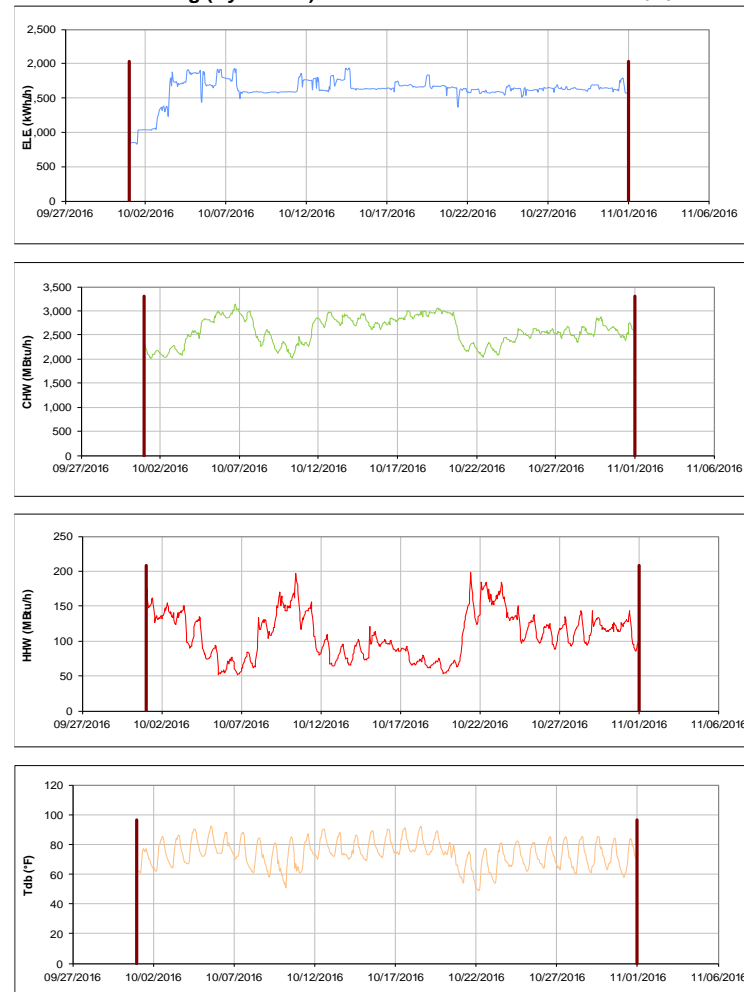
TAMU / BLDG #: 0434

Figure III-56 Hourly Whole Building Electricity, Chilled Water, and Hot Water Consumption for Luedecke Building (Cyclotron) during the Month of October 2016 and the Corresponding Hourly Outdoor Dry Bulb Temperature for College Station, TX

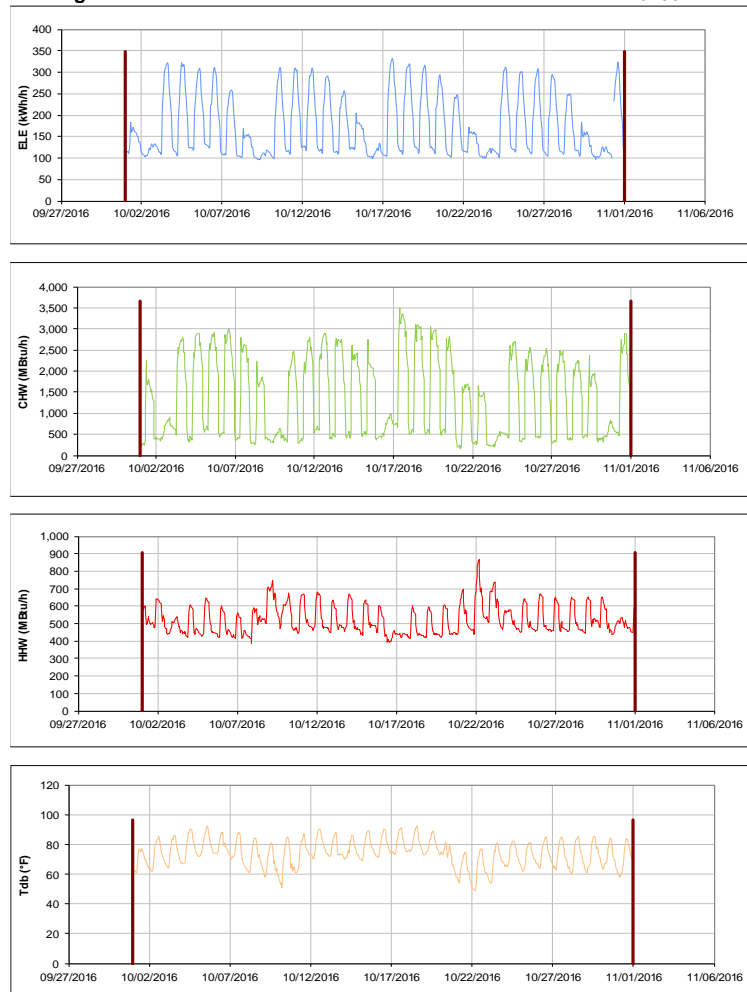
Harrington Education Center Office Tower TAMU / BLDG #: 0435

Figure III-57 Hourly Whole Building Electricity, Chilled Water, and Hot Water Consumption for Harrington Education Center Office Tower during the Month of October 2016 and the Corresponding Hourly Outdoor Dry Bulb Temperature for College Station, TX

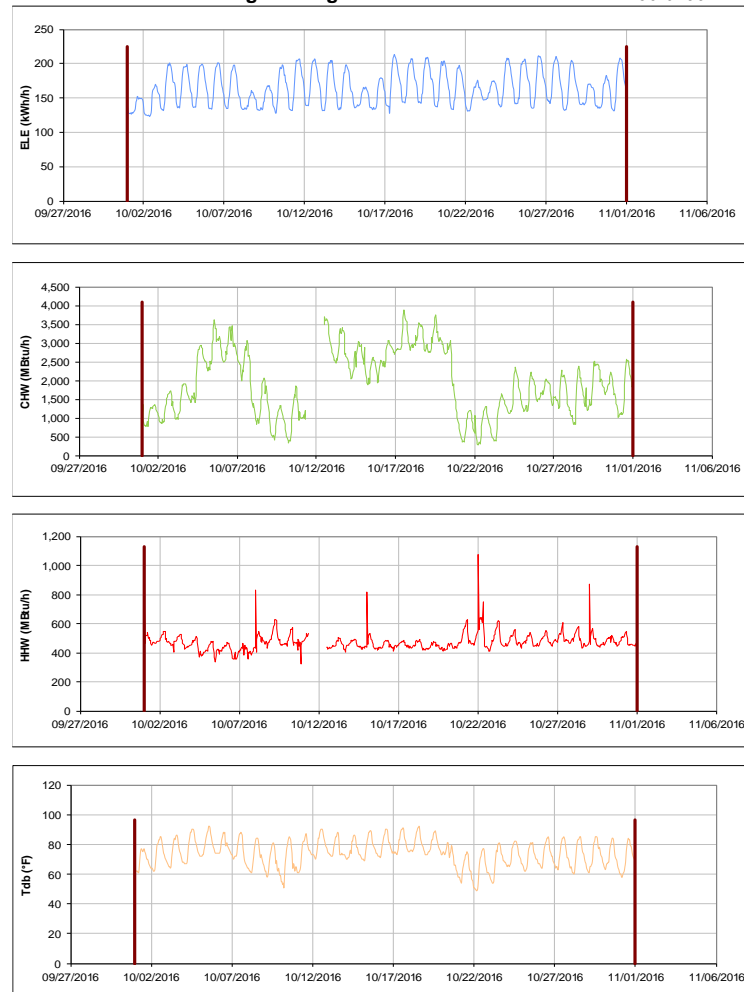
Reed-McDonald and Engineering Innovation Center TAMU / BLDG #: 1436-0499

Figure III-58 Hourly Whole Building Electricity, Chilled Water, and Hot Water Consumption for Reed-McDonald and Engineering Innovation Center during the Month of October 2016 and the Corresponding Hourly Outdoor Dry Bulb Temperature for College Station, TX

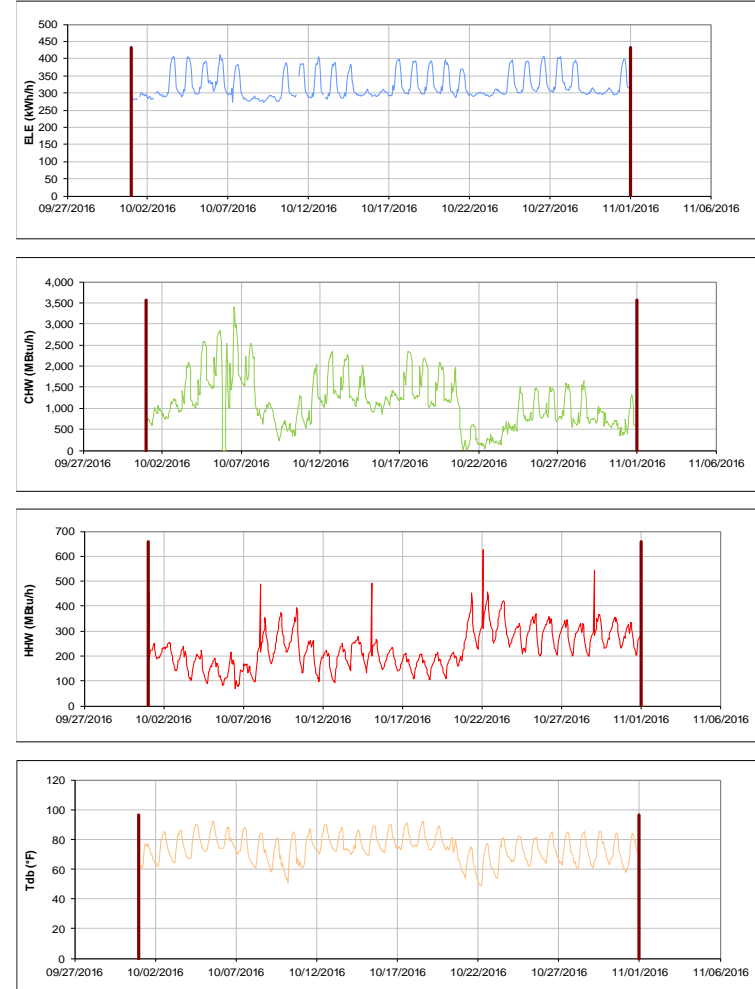
Oceanography & Meteorology Building TAMU / BLDG #: 0443

Figure III-62 Hourly Whole Building Electricity, Chilled Water, and Hot Water Consumption for Oceanography & Meteorology Building during the Month of October 2016 and the Corresponding Hourly Outdoor Dry Bulb Temperature for College Station, TX

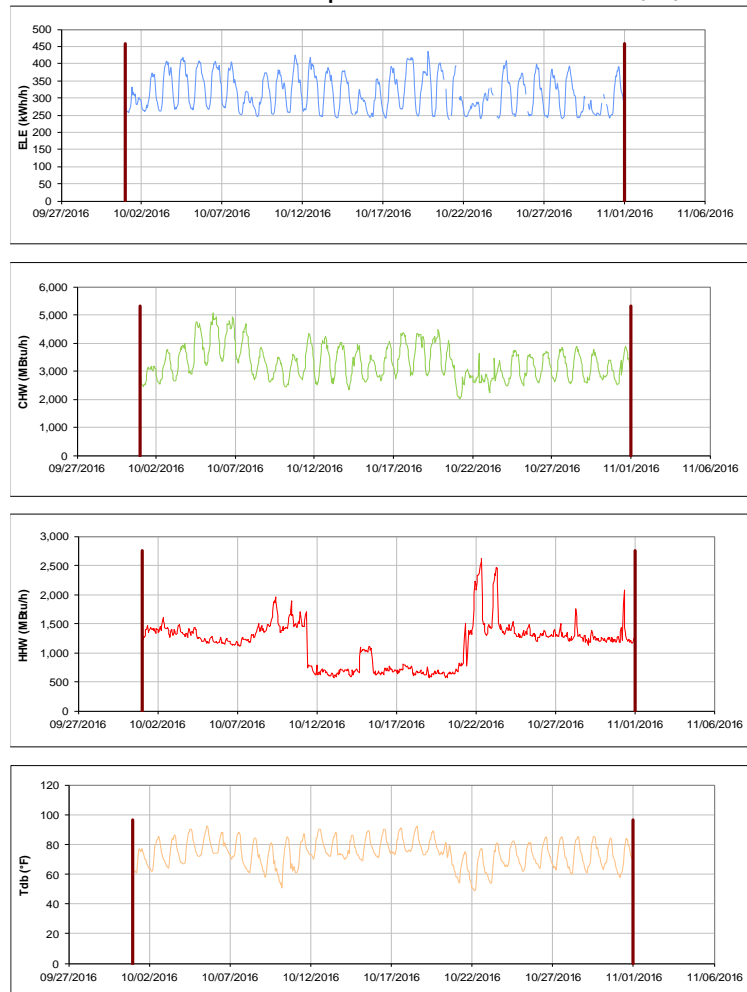
TAMU / BLDG #: 0446

Figure III-67 Hourly Whole Building Electricity, Chilled Water, and Hot Water Consumption for Rudder Tower and Theatre Complex during the Month of October 2016 and the Corresponding Hourly Outdoor Dry Bulb Temperature for College Station, TX

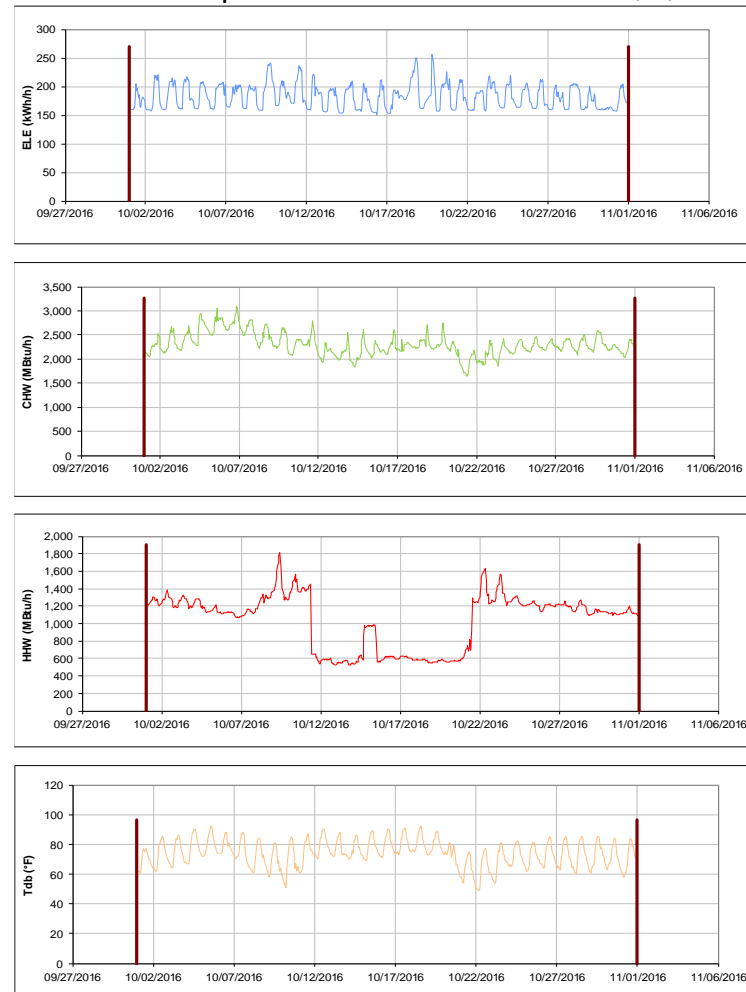
TAMU / BLDG #: 0446-A

Figure III-68 Hourly Whole Building Electricity, Chilled Water, and Hot Water Consumption for Rudder Theatre Complex during the Month of October 2016 and the Corresponding Hourly Outdoor Dry Bulb Temperature for College Station, TX
